PHASE I INSPECTION REPORT,
NATIONAL DAM INSPECTION PROGRAM.

Water Company #4

Inspection Team - GAI Consultants, Inc.
570 Beatty Road
Monroeville, Pennsylvania 15146

PHASE I INSPECTION REPORT
NATIONAL DAM INSPECTION PROGRAM
CITIZEN'S WATER COMPANY DAM #4
NDI# PA-507, PENNDER# 63-3

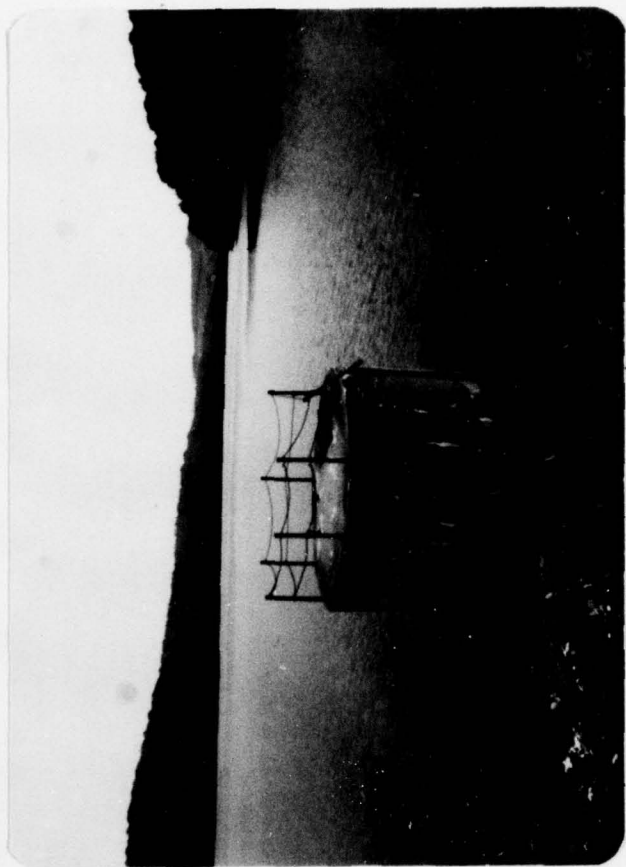
PHOTOGRAPH 4 Close-up view of the outlet controls at Dam #4. The gates are reportedly kept open and flow is said to be regulated at the treatment plant.

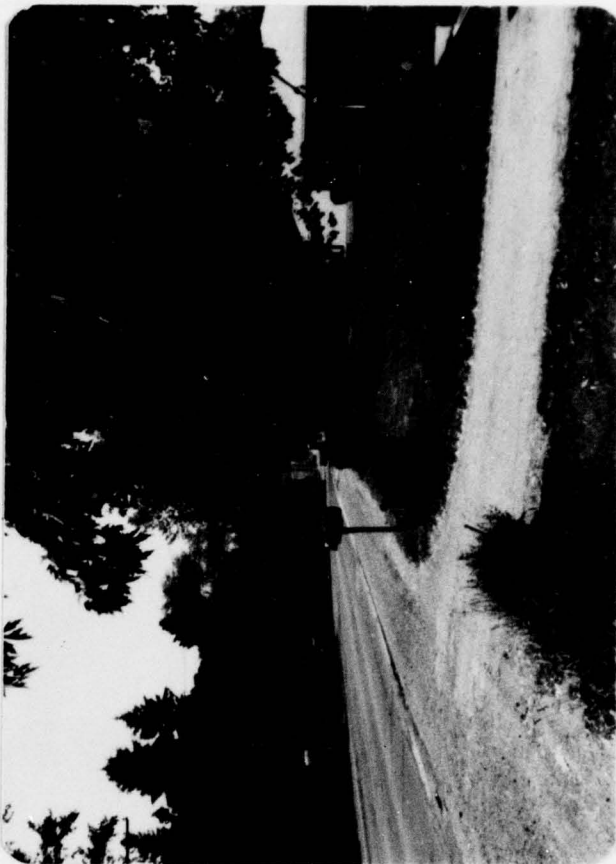
5. Downstream Channel. The downstream channel is a relatively flat, broad floodplain of Chartiers Creek. Vegetation within the floodplain is sparse consisting chiefly of shrubs and grasses. Approximately 2,000 feet downstream of the dam is a small community containing about 20 homes along PA Route 18. Many of these dwellings would be affected by a sudden failure of the embankment. Other dwellings in the community of Franklin Farms are also located within the Chartiers Creek floodplain approximately 6,000 feet from the dam. However, as the floodplain is quite wide in this area, the effects of a sudden breach appear minimal. Based on the above observation, the hazard rating for the facility is "high" (see Photograph 8).

PHOTOGRAPH 8 View of a residential area located approximately 2,000 feet downstream of the dam.

c. the owner adapt their proposed emergency contingency plan for maintaining a safe potable water supply to include a warning system in the event of an emergency embankment condition.

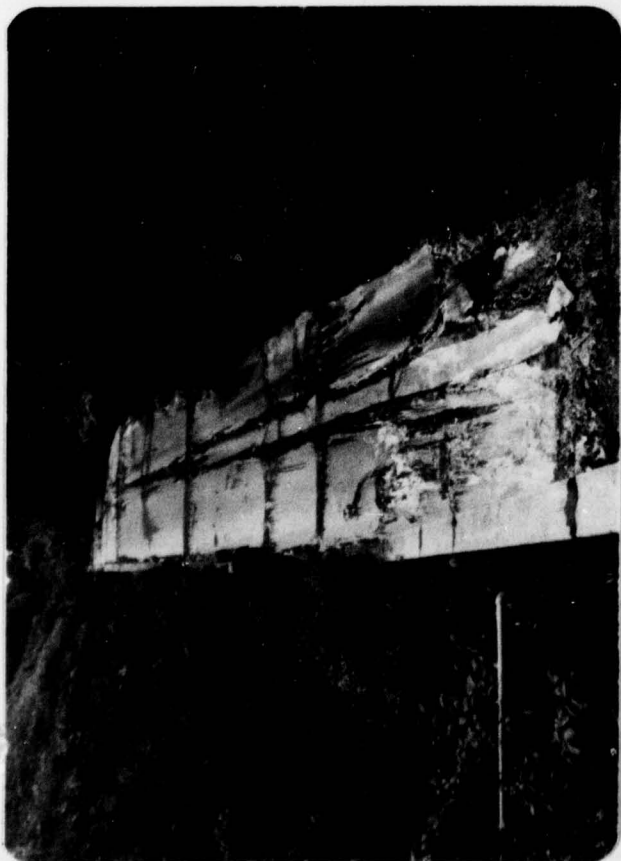
1. Spillway. The upper two-thirds of the spillway including the wingwalls and channel floor appeared to be in fair to good condition. Joints and popouts have been sealed with bitumen. The bottom third of the spillway chute above the stilling basin is in poor condition with random spalling and severe scaling evident. Leakage through the left spillway wall appears to be causing some concrete deterioration. The ogee portion of the spillway and plunge pool walls appear to be in good condition (see Photographs 5 and 6).

Fair to good condition in upper two-thirds. Joints and popouts have been filled with bitumen. Flow surface in reasonably good condition. Seep through left side of spillway at wall causing concrete deterioration. Bottom third in poor condition with spalling and severe scaling evident. Plunge pool walls in good condition.

PHOTOGRAPH 5 View of the spillway at Dam #4 taken from the plunge pool area. Note the deteriorated condition of the structure near the entrance to the plunge pool.

a. the owner investigate and initiate remedial repair of the deteriorated spillway section. The investigation should include an assessment of the seepage source(s) within and adjacent the spillway with possible remedial schemes to direct the seepage through the underlying drainage system.

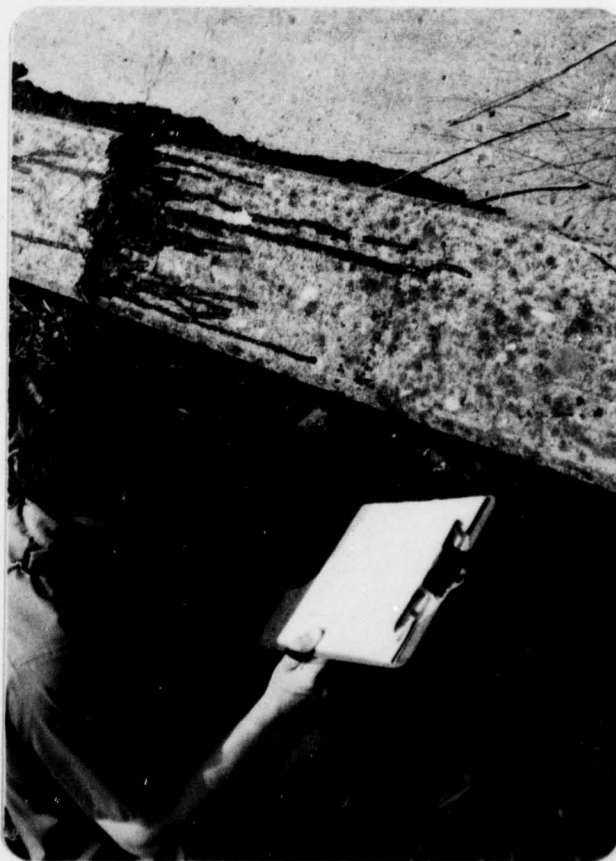
b. Embankment. The dam embankment appears to be in good condition. There is no evidence of any cracking or sloughing. Settlement of the embankment crest was found to be minimal not exceeding approximately 4 inches. The upstream slope is covered with a well graded slag with maximum particle size of about 6 inches. Minor slope erosion was evident in a few areas on the upstream slope indicating that the protection provided by this riprap material is questionable. The downstream slope contains a 3.5-foot wide bench drained with a stone gutter located approximately 25 feet below the dam crest. No indications of seepage through the embankment slope were observed during the field investigation. However, a seep was observed adjacent the right spillway wingwall with flow emanating about 10 feet below the bench (visually estimated to be 5 gpm). Leakage is also visible through the spillway slab slightly above this level indicating the source of the seep may originate in the abutment (see Photograph 7).

Flow along spillway at junction of embankment. Flow apparently originates 10 feet below bench and is visually estimated to be approximately 5 gpm. Leakage is also visible through spillway indicating the source of the above seep may originate underneath the spillway.

PHOTOGRAPH 7 View of seepage emanating adjacent the spillway sidewall approximately 10 feet below the embankment bench level.
